Strength evaluation of the Prussian vaults made from brick aggregate concrete

R.B. Orlovich,
R. Nowak,
West Pomeranian University of Technology
Szczecin, Szczecin, Poland

N.I. Vatin,
V.V. Bespalov*,
Peter the Great St. Petersburg Polytechnic
University, St. Petersburg, Russia

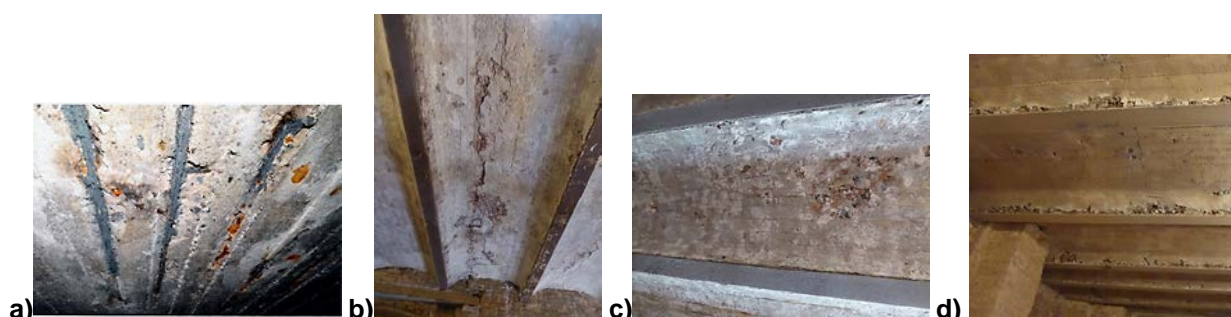
Figure 2. Types of damages in Prussian vaults made from brick aggregate concrete: a – corrosion of steel beams, b – cracks, c, d – degradation of the material

- Corrosion of bottom flanges for steel I beams are frequent especially for basement floors and unheated rooms when humidity level is high as well as external slabs exposed to moisture such as terraces, balconies and wet cores (Figure 2). Moreover, webs also frequently corrode in these conditions, which are only detectable by exposing the whole beam.
- Cracks on the plaster are also common along the beams caused by load or expansion caused by corrosion underneath (Figure 2a), as well as cracks (Figure 2b) and even loss of material from the floor surface (Figure 2 c, d).

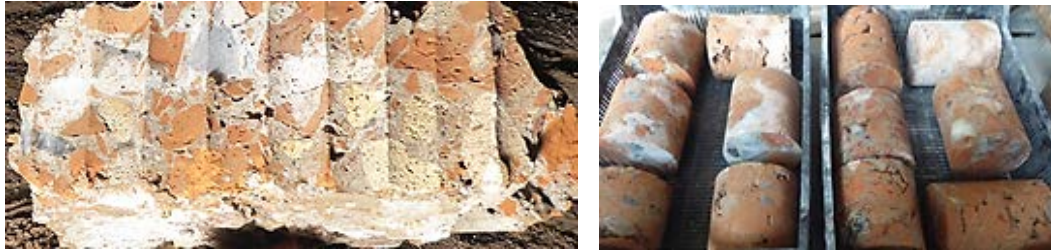
Figure 4. The structure of the brick aggregate concrete vaults and core samples in the compressive test

Compressive and tensile strengths obtained from core samples can be used in the equations 1-3 for the calculation of overall strength for vaults in question. On the other hand, values calculated in this manner do not reflect real boundary conditions of the vaults especially for the zones close to supports, since there are probable damages occurred during long operation time, cracks, material degradation, etc. Therefore, the authors of this study performed in situ tests on 5 slabs with 50 cm width (b) cut out from the vaults between beams; including well preserved and damaged sections, as explained in Figures 5 and 6.

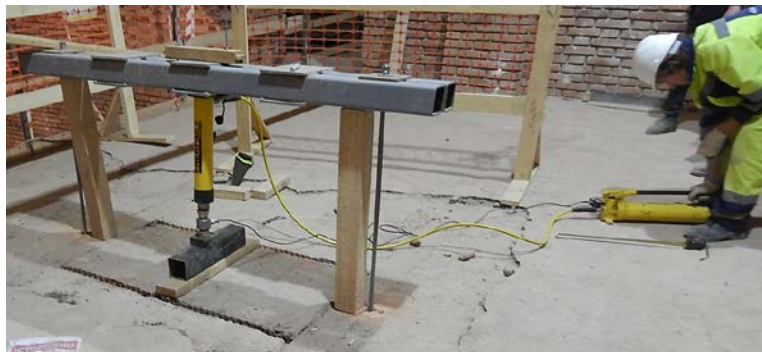
Figure 7. Test setup during the process

Load was applied by hydraulic actuator as shown in Figures 6 and 7, the deflections of the sections were measured in the mid-span ($L/2$) and the widths of existing as well as new cracks were also noted.

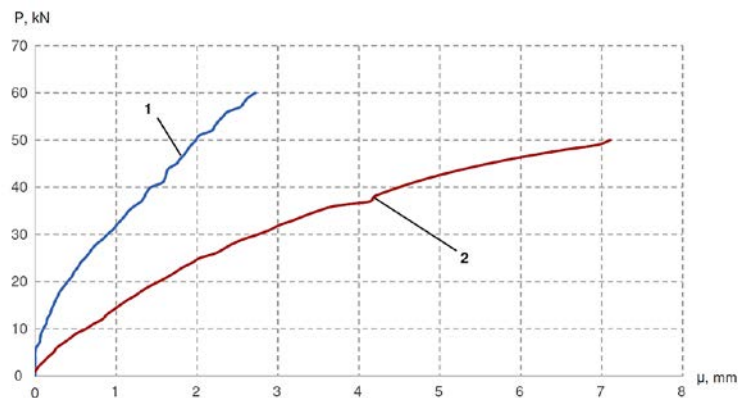
Figure 9. Experimental tests curves „load-deflection”: 1 – four non-damaged vault results (Figure 6a), 2 – one damaged vault (Figure 6b)

Figure 9 shows the measured correlation between load and deflection “P- μ ” for chosen vault sections. It was experienced that cracked vaults resulted in lower stiffness than non-damaged ones as expected (approximately twice lower according to the diagram). Additionally, applying and releasing 40 kN concentrated load made system exhibit elastic behavior, while it became brittle after this limit and cracks appeared.

After applying 10 and 40 kN loads discussed above, 60kN was also experienced on these actions which did not also cause destruction. Consequently, although the structure exhibited a significant bearing capacity; the repairing alternatives can still be required as follows [9, 10]:
