Research article

Seismic damage mechanism of weak beam-column joint frames

Keywords: reinforced concrete, structural concrete, special moment resisting frame, building frame, beam-column joints, shake table test, progressive collapse

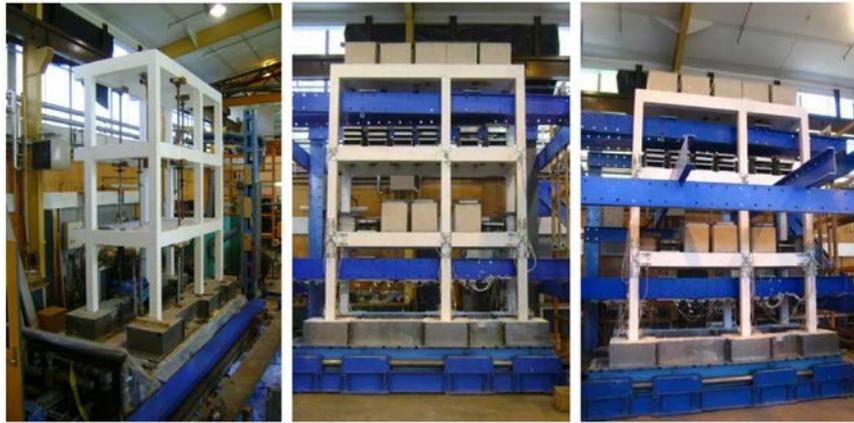
(a) 1:2.5 scale three storey two bays by one bay deficient RC model tested by Quintana et al. [10]

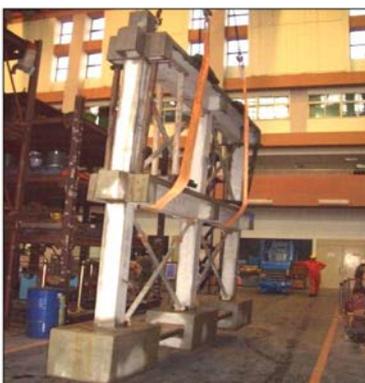
(c) 2:2.25 scale two storey and two bay RC frame tested by Yavari et al. [12]

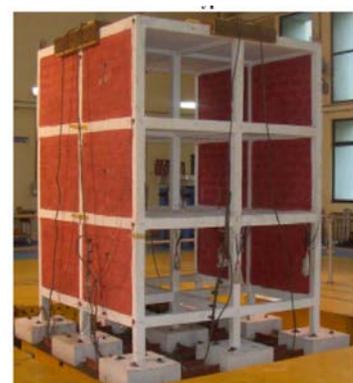
(d) 1:3 scale three storey RC model tested by Sharma et al. [13]

Figure 1. Shake table tests investigations on deficient RC frame models.

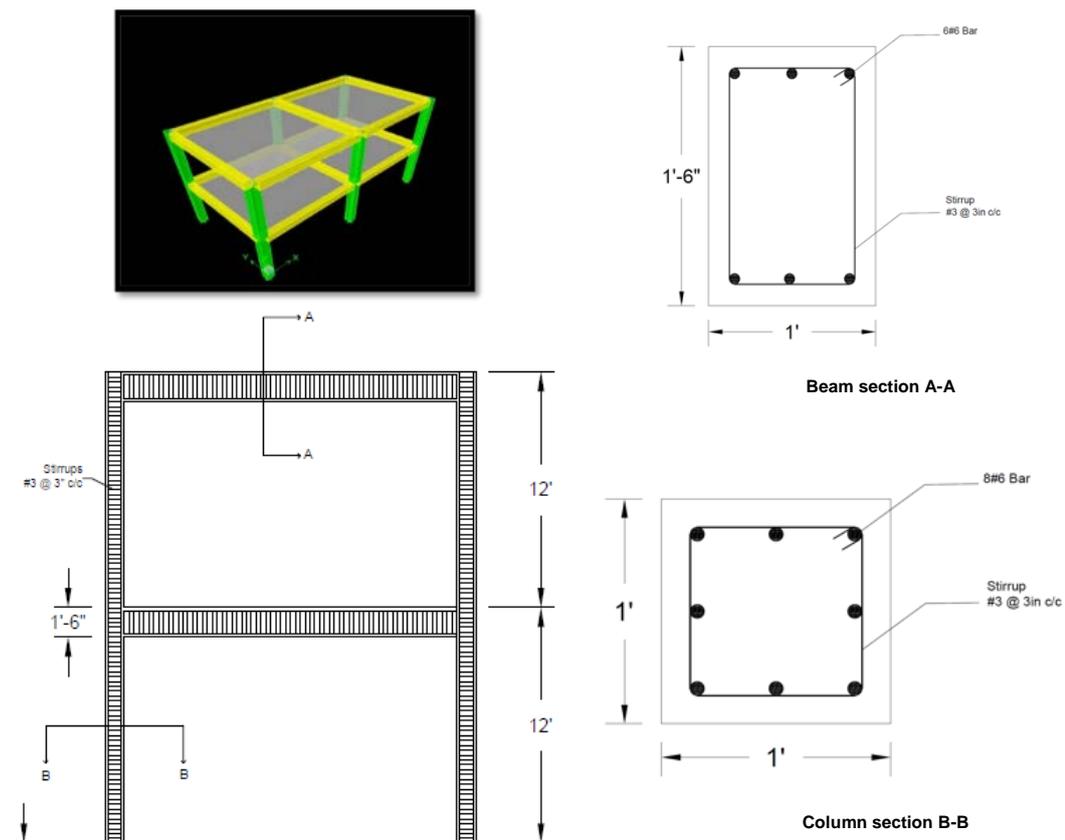
Figure 2. Geometric and design layout of prototype RC frame.

observe their damage response. In particular, a RC frame with a two storey structure was considered, typically employed for low rise schools, hospital or apartment type public buildings. The considered structure consisted of a 2 by 1 bay frame, with each bay length of 5487 mm (18 feet) and storey height of 3658 mm (12 feet) for both the stories, as shown in Fig. 2. The representative frame structure was designed according to static force-based procedures (BCP-SP 2007/UBC 97) [29–30], considering high seismic zone of 4.0 (0.40 g design peak ground acceleration) with stiff soil type B (NEHRP classification). The modeling and design were carried out using the design software CSI ETABS considering all load combinations as per the code. For the material properties, 21 MPa (3000 psi) concrete and 414 MPa (60,000 psi) rebar yield strength were considered in the design process. The design model was detailed as per the ACI-318-14 [31] recommendations for the SMRF provisions. Fig. 1 also shows the design details of the prototype structure.

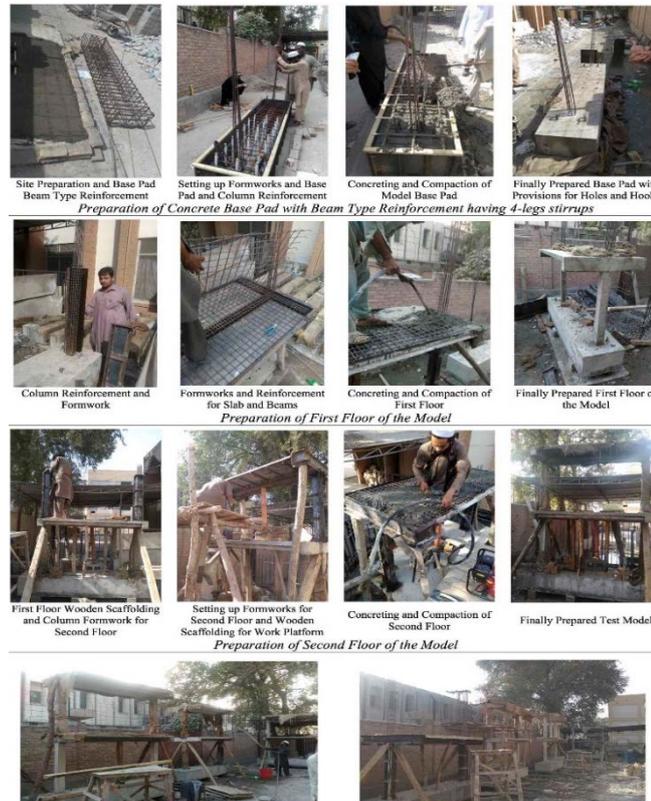
Figure 3. Test frames construction stages.

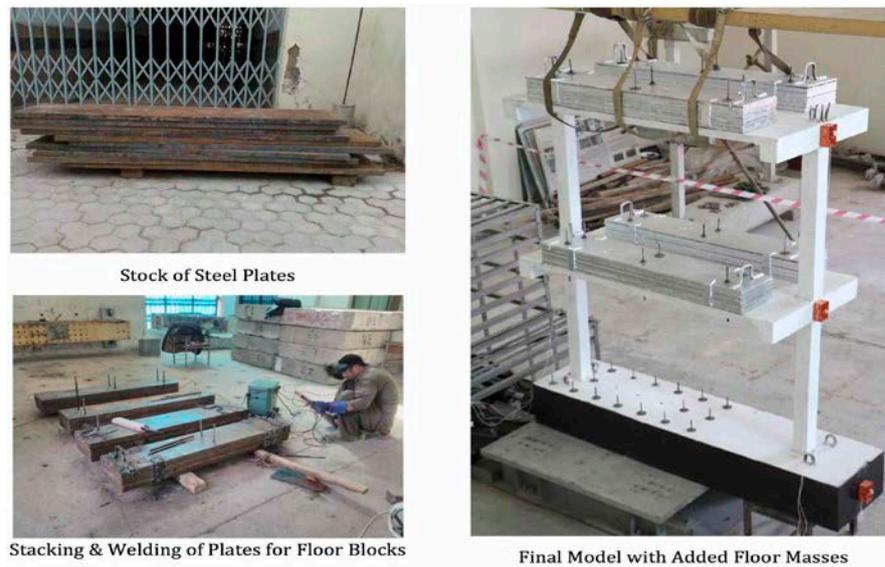
Figure 4. Added floor mass preparation and setup for artificial mass simulation.

The concrete mix proportion of cement:sand:coarse aggregate, for both design specified strength of 21 MPa (3000 psi) and reduced strength of 14 MPa (2000 psi) are shown in Table 1. Fig. 3 shows the sequence of construction for the 1:3 scaled frame models. Due to scaling and similitude requirements the reduced scale models were subjected to gravity and seismic mass less than the required. To satisfy the condition of mass simulation for the reduced scale test models, additional floor mass was applied following the mass simulation model [10, 32]. On each floor level extra mass of 1200 kg was applied through steel blocks mounted and fixed to the floor by means of fully secured 13 mm (½ inch) steel bolts as shown in Fig. 4.

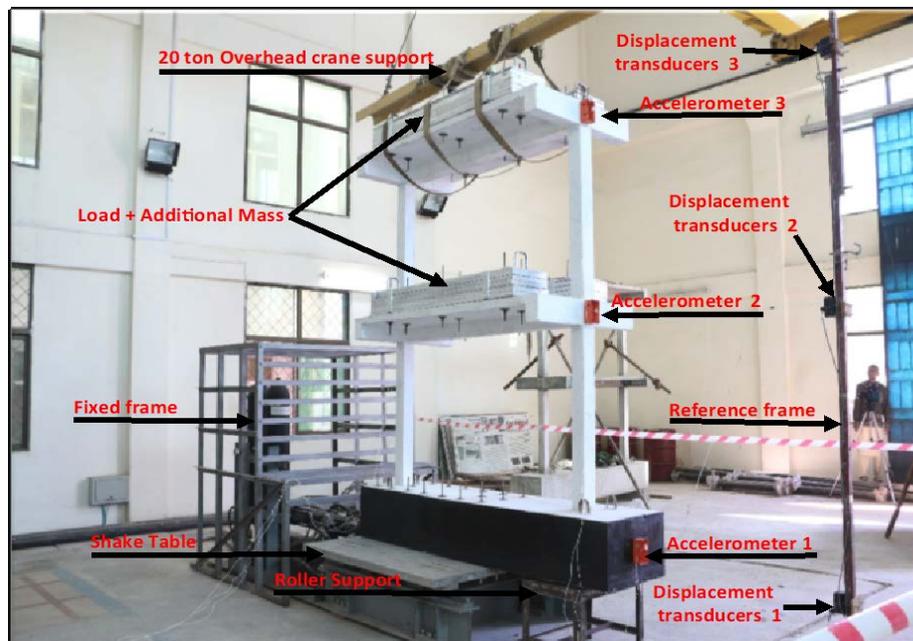
Figure 5. Test frame instrumentation and shaking setup.

The test model's setup on the shaking simulator and model instrumentation are shown in Fig. 5. The objective of experimental testing was to observe the global response of the test frames, so only external instrumentation was employed in the form of six accelerometers and three linear displacement transducers. The instruments sensitivity, maximum capacity and conversion coefficient are reported in Table 2. On each floor level (mid position of joint panel region) and at the base pad level, three accelerometers were installed on the front and back sides of the test models in order to record floor and base pad accelerations. For recording the displacement at each floor and pad level, three displacement transducers were attached to a fixed steel frame, which was installed in-line with the model in-plane position.

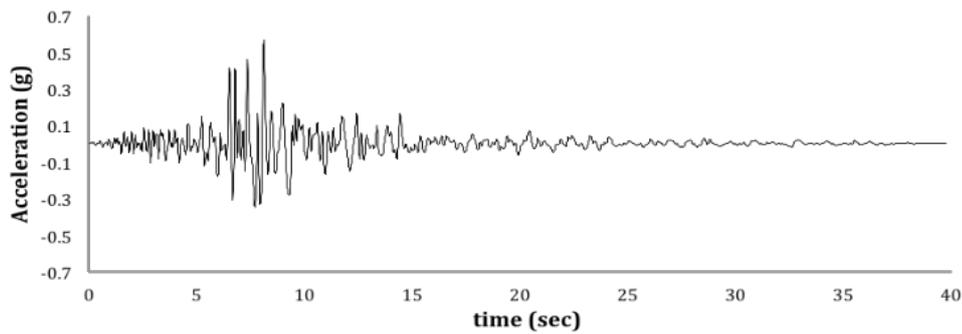
Figure 6. Input time history record of 1994 Northridge Earthquake.
