Research article

The GPR survey method in combination with destructive testing methods for the hydraulic structures technical condition studying

Abstract. The study examined the technical condition of hydraulic structures (HS) to plan their reconstruction, restoration and development of protective measures. The Sarpinskaya Watering and Irrigation System (SWIS) in the Republic of Kalmykia was the object of study. Promising research and monitoring methods were used: testing of concrete core samples using universal testing machine MIM.4-1000 and ground penetrating radar probing (by the GPR OKO-3) with ground penetrating radar survey of HS. Based on the results obtained, it can be concluded that concrete and reinforced concrete structures on the territory of the SWIS (namely, pumping station No. 1) have low strength, which is explained by their long service life and the lack of major repairs. The studied core samples collapsed under a minimum load of 116...118 kN. This indicates severe wear of the concrete coating of HS, aggravated by the close occurrence of groundwater. Further destruction of the concrete coating is inevitable, and therefore urgent repair and reinforcement of the st

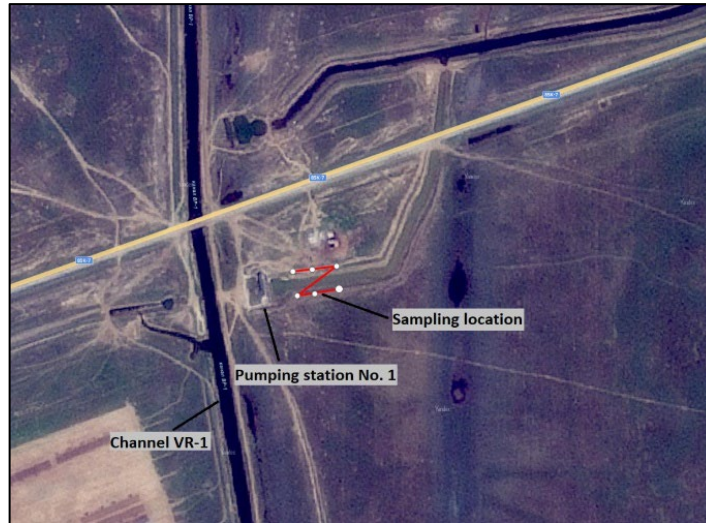
In 2023, georadolocation survey was carried out at certain SWIS sites in the Oktyabrsky District of the Republic of Kalmykia using the GPR OKO-3. Concrete samples were taken from some sections of the concrete lining of the drainage channel for further study in the laboratory (Fig. 1).

Figure 1. Places of concrete cores sampling.

The cores were taken from the area of pumping station No. 1 of the SWIS. The sampling site was chosen taking into account the minimum possible damage to HS, at a distance of 600 mm from the joints and edges of the coating, in the area free from reinforcement. The number and location of drilling spots are determined by local conditions.

The GPR survey was performed at the place where the core samples were taken (Fig. 1). The GPR survey of HS was carried out using the GPR OKO-3, manufactured by JSC Geotech (Russia), equipped with a 2-frequency antenna unit 150+400 MHz (Fig. 5).

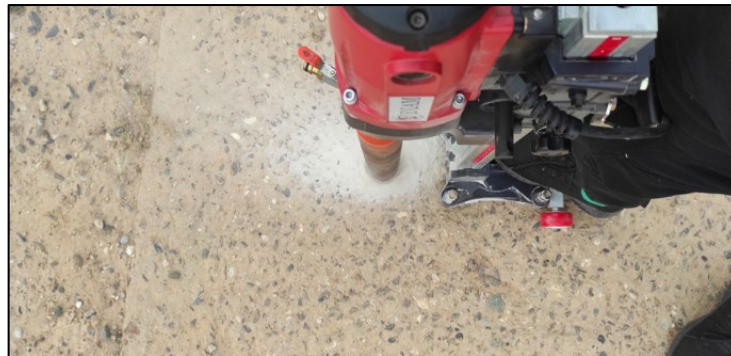
To obtain complete and accurate information about the HS condition, a destructive testing method, “Core sampling and testing” was used, which was carried out on selected sections of HS with the use of a diamond drilling rig (Fig. 2).

Figure 2. Process of cutting the cores using a diamond drilling rig.

However, after the core was extracted, such a structural characteristic as load-bearing capacity of the structure under study may change. Therefore, it is recommended to extract a concrete sample only with the marks made in advance by the developer, so that the loss of a part of the structure would not affect its strength characteristics in any way. The place, from which the core was removed, was filled with concrete and the surface was leveled.

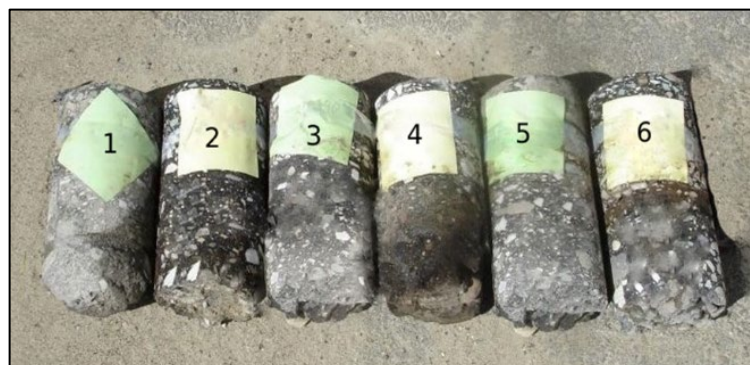
After cutting, the concrete core samples were sent to the laboratory to determine their strength by measuring the minimum force required for destruction. The number of samples in the series was 6 pieces (Fig. 3).

Figure 3. Concrete samples from the SWIS.

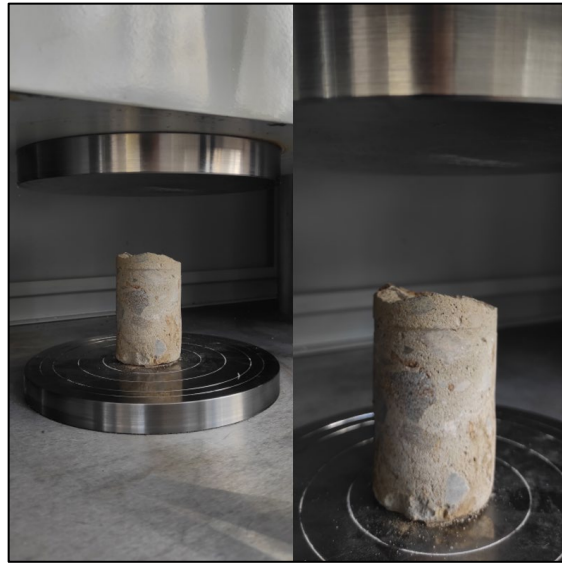
Compression tests of samples were carried out in the laboratory of the Federal Scientific Centre of Agroecology, Complex Melioration and Protective Afforestation of the Russian Academy of Sciences on universal testing machine MIM.4-1000 (Fig. 4). The laboratory analysis consisted of a static load with its constant growth rate, and the subsequent calculation of stresses taking into account the elastic work of the material.

Figure 4. Testing of a core sample using a universal testing machine MIM.4-1000.

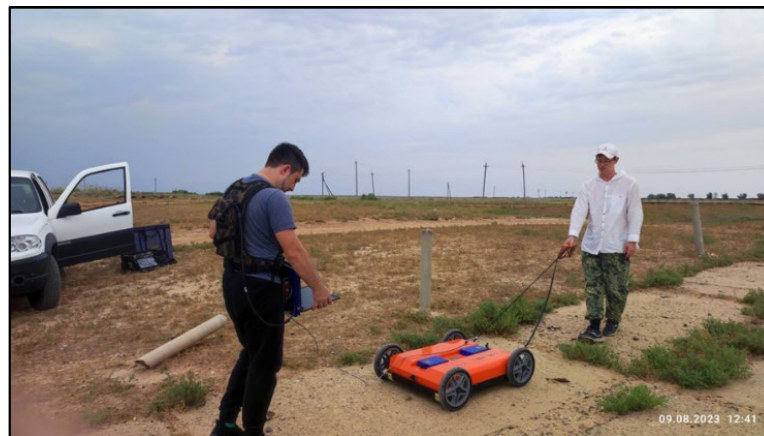
Figure 5. The GPR survey.

Both antennas of the device are shielded, which prevents electromagnetic radiation from entering the upper half-space of the device, and suppresses reflection from objects of the upper half-space [25]. The 150 MHz antenna probes the soil to a depth of up to 12 m with a resolution (minimum size of detectable objects) of 0.35 m. The 400 MHz antenna provides probing to a depth of 5 m but with a more accurate resolution of 0.15 m. In this work, due to the small capacities of the probed soils, the main instrument was the 400 MHz antenna, the 150 MHz antenna served as a control.

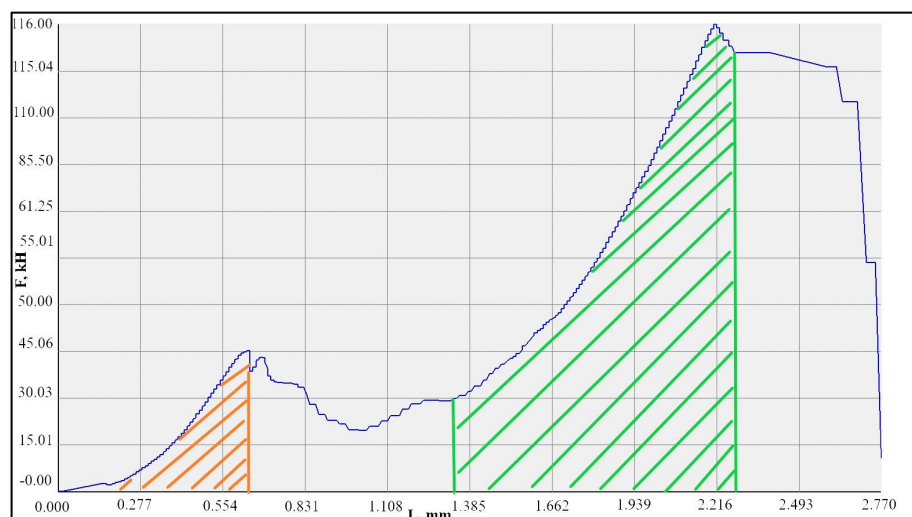
The graph in Fig. 6 shows fluctuations and a subsequent sharp increase in the load during compression of the core sample on a universal testing machine. This graph is typical for all selected cores, since destruction occurs throughout the area under study.

Figure 6. Deformation diagram of the core sample, kN.

When loading the test sample, in the area highlighted in orange in Fig. 6, there is an increase in the deformation curve from 0 to 42 kN. A repeated jump can be observed in the area highlighted in green. In this part, the graph has a stronger amplitude from 30 to 116 kN.

The graph shows that the deformation runs along the layering with an exorbitant characteristic. It follows from this that the site is subject to destruction.

From Table 1, it can be seen that samples No. 3, 4, 5, 6 were destroyed at a minimum load of 116...118 kN. These data indicate a strong wear of the concrete coating of HS, which is complicated by the close occurrence of groundwater, which will cause further damage to the coating.

1. Concrete and reinforced concrete structures on the territory of the SWIS, namely pumping station No. 1, have low strength, which is due to the long service life of the structures and the lack of major repairs. Tests of concrete core samples showed that the samples collapsed at a minimum load of

116...118 kN. This indicates severe wear of the concrete coating of HS, which is aggravated by the close occurrence of groundwater. Further destruction to the concrete coating is inevitable, which requires urgent repair and reinforcement of the structures.

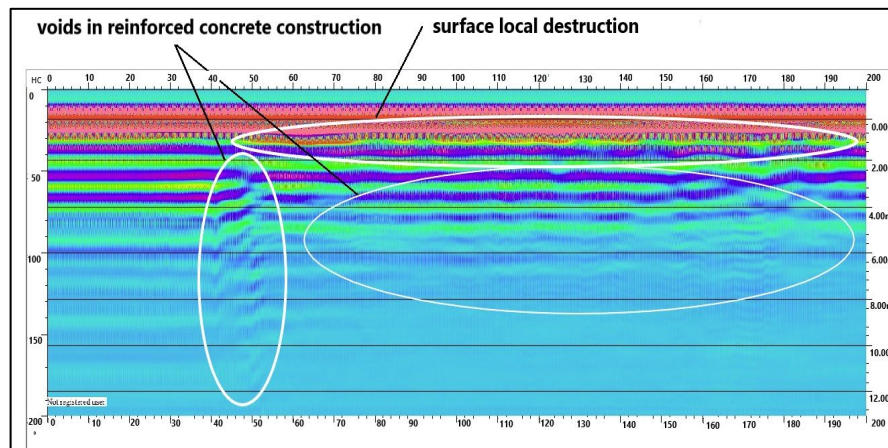
1. Graphs of time sections recorded by the variable density method, on which the horizontal axis indicates the distance in meters, and the vertical axis indicates the time of arrival of reflected signals in nanoseconds. In subsequent work in the GeoScan32 program, when processing signals, interference is weakened or removed from the record as much as possible, and useful ones are highlighted [15].
2. The electrical properties of metals are fundamentally different from the properties of any soils, therefore, their detection in the soil by the GPR method does not cause significant difficulties, provided that metal objects are found within the probing depth of the device and linear dimensions exceed the resolution of the device. Concrete structures in the soil also cause changes in the propagation of electromagnetic fields (Fig. 7, 8).

The geomage (Fig. 7) shows the revealed inhomogeneities of the body: surface local fractures and voids in the reinforced concrete structure of the structure, when scanning with the antenna side of the AB 150/400 MHz, having a width in plan of 0.5...1.5 m and directed across the body of the dam. In this image, we can observe fluctuations through the entire body of the concrete channel bed and up to 12.5 m, which can be formed by voids in the body of the dam [25].

Figure 7. Image from the GPR OKO-3.

2. The study of the concrete coating using the GPR method on the territory of the SWIS using the GPR OKO-3 with a 2-frequency antenna unit of 150+400 MHz during the diagnosis of the technical condition allowed us to identify the following. Pronounced voids of soil decompression under the concrete base of the body of the dam. Water filtration points through the body of the dam. All of them are characterized by an increase in soil moisture from 3 to 40 %, interpreted through a change in its dielectric constant, which leads to the expansion of the concrete base of a part of HS. Due to the rise of groundwater to the base of the body of the dam, the strength of individual elements of HS is subjected to greater wear, which will lead to the rapid destruction of the concrete coating.

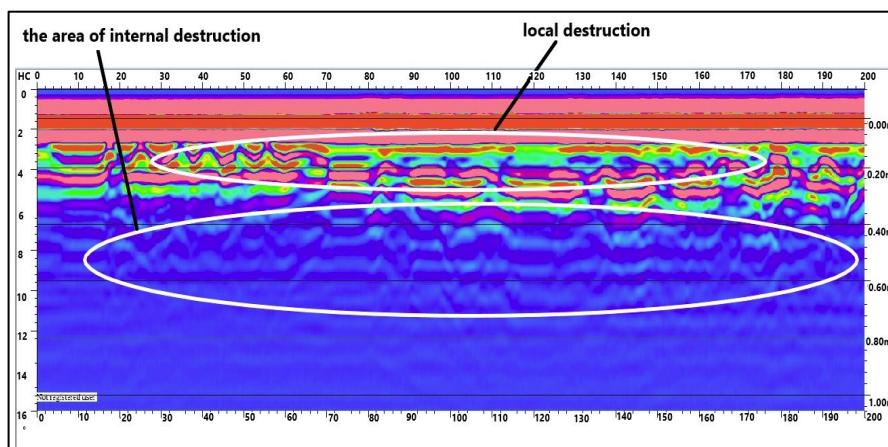
Fig. 8 shows the result of a detailed study of the zone, which was carried out by scanning using the AB 150/400 MHz antenna unit. Some of these zones are visually distinguishable in the lower part of the slope in the form of leaks and filtration passing through the body of the structure. This filtration can be traced from a depth of 0.06–0.40 m to the groundwater level.

Figure 8. Image from the GPR OKO-3.
